**US Army Corps
of Engineers**

Technical Report HL-94-1
May 1995

Demonstration Erosion Control Project Monitoring Program

Fiscal Year 1993 Report

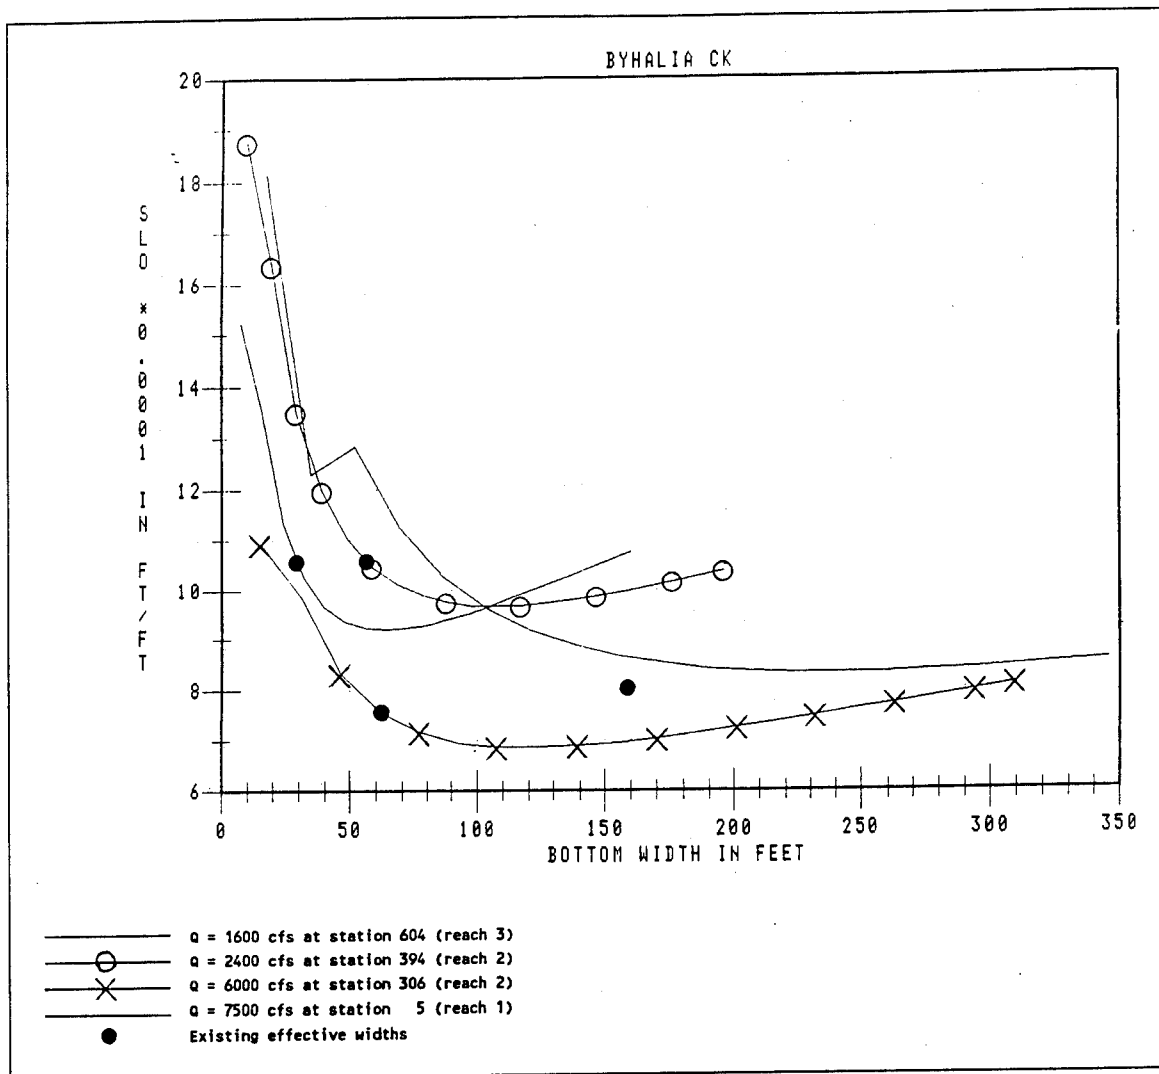
The HYD.OUT file lists the physical and water properties and a table of stable channel width-depth-slopes for the given water discharge, sediment concentration, and particle size. DSS produced the graphs shown in Figure 128. The legend shows the water discharge and the corresponding channel station. The existing effective widths are plotted on the curves to show what the design slope should be to be in balance with the existing channel width. In reaches 2, 3 and 4, that slope is considerably less than the existing slope. However, this procedure resulted in very similar slopes from reach to reach on Byhalia Creek. An average value, 0.001 ft/ft, was selected except in reach 4 where the value was increased to 0.0015 ft/ft. The calculated slope in reach 4 is about 0.001, also. However, this is a short reach, and engineering judgement suggested the width can be reduced from existing conditions by placing some bank stabilization as required.

Figure 128. Stable channel calculations by reach

The slope of reach 2 is of considerable interest since it plots lower than reach 1. This is attributed to the relatively steep banks in reach 2 as compared with those on reach 1. The irregular shape of the width-slope curve in reach 1 is due to a change in the bed regime between widths of 30 and 50 ft.

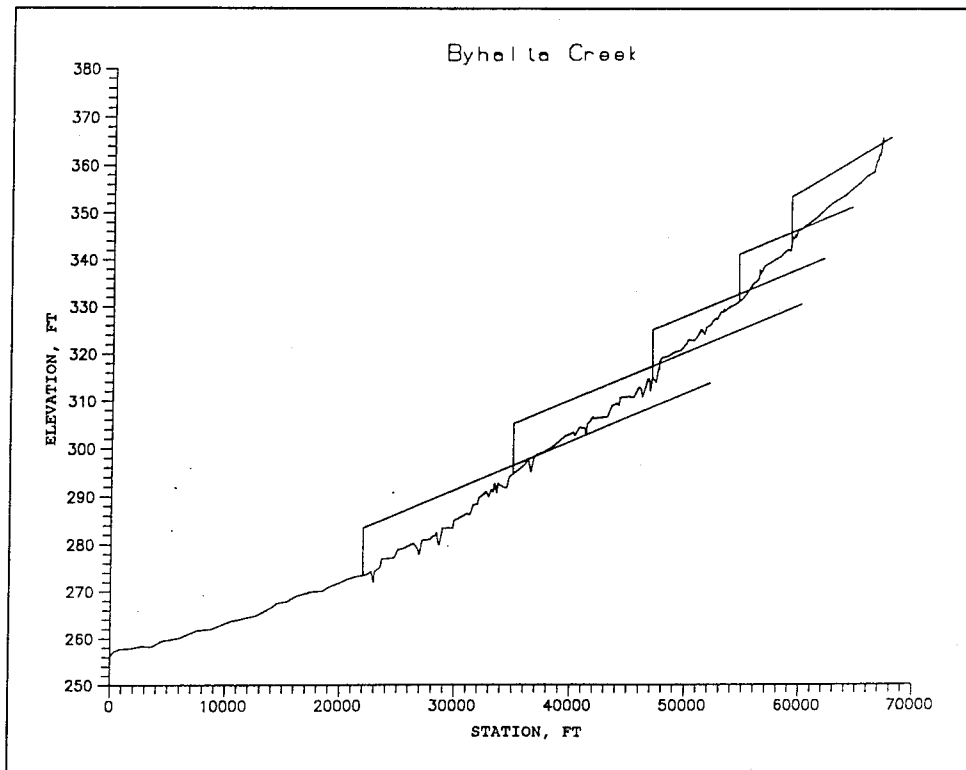
Figure 129. Grade control structure spacing

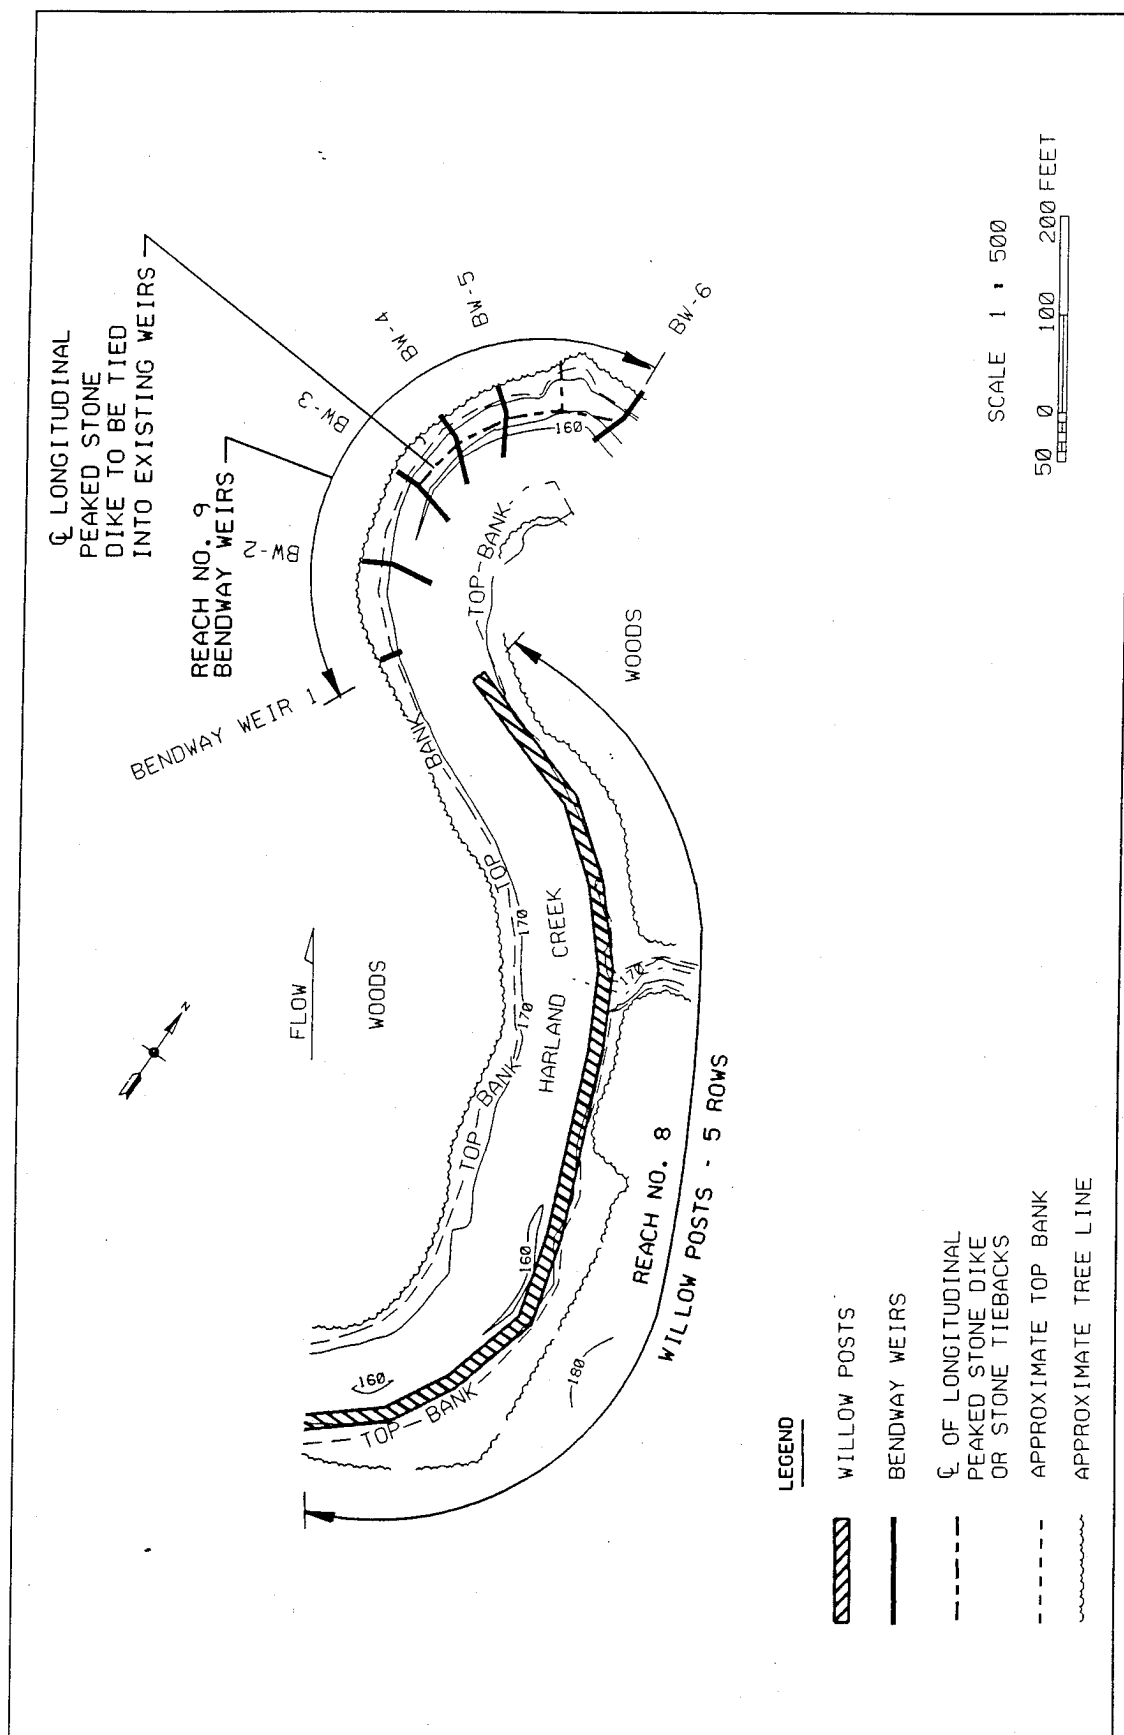
Reach geometry (curved, straight, then curved) (Figure 134): Section 1, curved, 275-ft radius (large), 86 deg, top bank length 410 ft; Section 2, straight for 190 ft; Section 3, curved, 425-ft radius, 55 deg, top bank length 410 ft; total top bank length of reach 1,010 ft. Bank protection consists solely of willow posts, five rows, 3 ft between rows, willows on 3-ft centers, first row positioned at water's edge. Approximately 1,630 willows will be used.

Reach geometry (curved) (Figure 134): 175-ft radius, 178 deg, top bank length 540 ft. Seven bendway weirs, all angled 20 deg upstream, lengths of 32, 29, 17, 30, 37, 20, and 37 ft, and spaced evenly at intervals of 75 ft. All weir heights were set at el 164 ft NGVD for the stream ends and el 166 ft NGVD for the bank ends.

Figure 134. Harland Creek test site, reaches 8 and 9

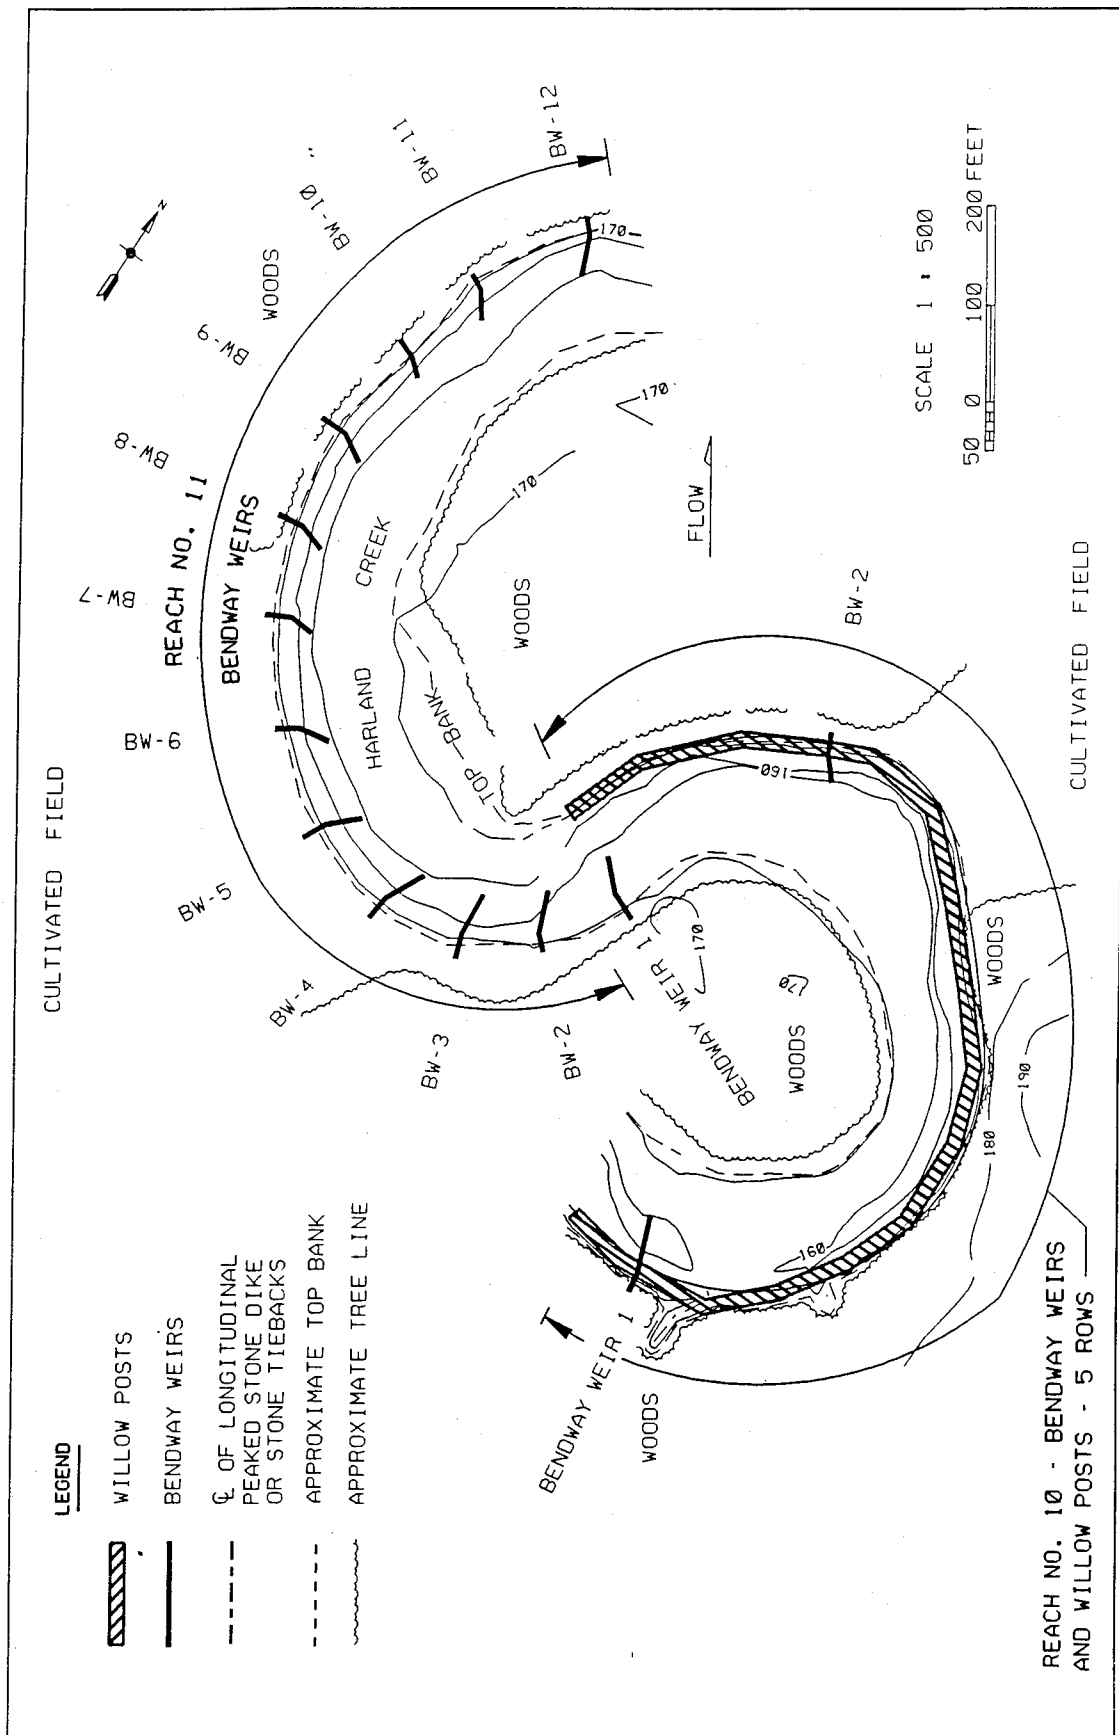
Reach geometry (curved, straight, then multi-radius curve) (Figure 135): Section 1, curved, 245-ft radius, 146 deg, top bank length 620 ft; Section 2, straight for 180 ft; Section 3, 150-ft radius, 71 deg, top bank length 185 ft; Section 4, 345-ft radius, 50 deg, top bank length 300 ft; total top bank length of reach 1,285 ft. Bank protection consists of a combination of willow posts and two bendway weirs. The willow posts will be planted in five rows, spaced 3 ft between rows, with willows spaced 3 ft apart, with the first row located at the water's edge. Approximately 1,805 willows will be planted in this reach. The two bendway weirs were positioned approximately 85 and 990 ft from the upstream end of the bend, with lengths of 60 and 30 ft, angled 15 and 10 deg upstream, with stream ends at el 164 ft NGVD and bank-end elevations of el 166 ft NGVD. Geometrically speaking the outer bank of this bend is extremely irregular. Bendway weirs would not likely be effective due to the irregular flow patterns. However, the two bendway weirs specified in this plan should help in reducing pressure on the outer bank and realigning currents in the immediate area downstream of the weirs. The upstream weir should also help in aligning the currents entering Reach 10.

Reach geometry (multi-radius bend) (Figure 135): Section 1, curved, 220-ft radius, 108 deg, top bank length 415 ft; Section 2, curved, 415-ft radius, 108 deg, top bank length 780 ft; total top bank length of reach 1,195 ft. Twelve bendway weirs, all weirs spaced evenly at intervals of 100 ft, all angled 20 deg upstream (except for weir 12 which is angled 10 deg upstream), and all built to a length of 40 ft except for weirs 6, 8, and 11, which are 38, 46, and 46 ft, respectively. All weir heights were set at el 162 ft NGVD for the stream end and el 164 ft NGVD for the bank end.

Figure 135. Harland Creek test site, reaches 10 and 11

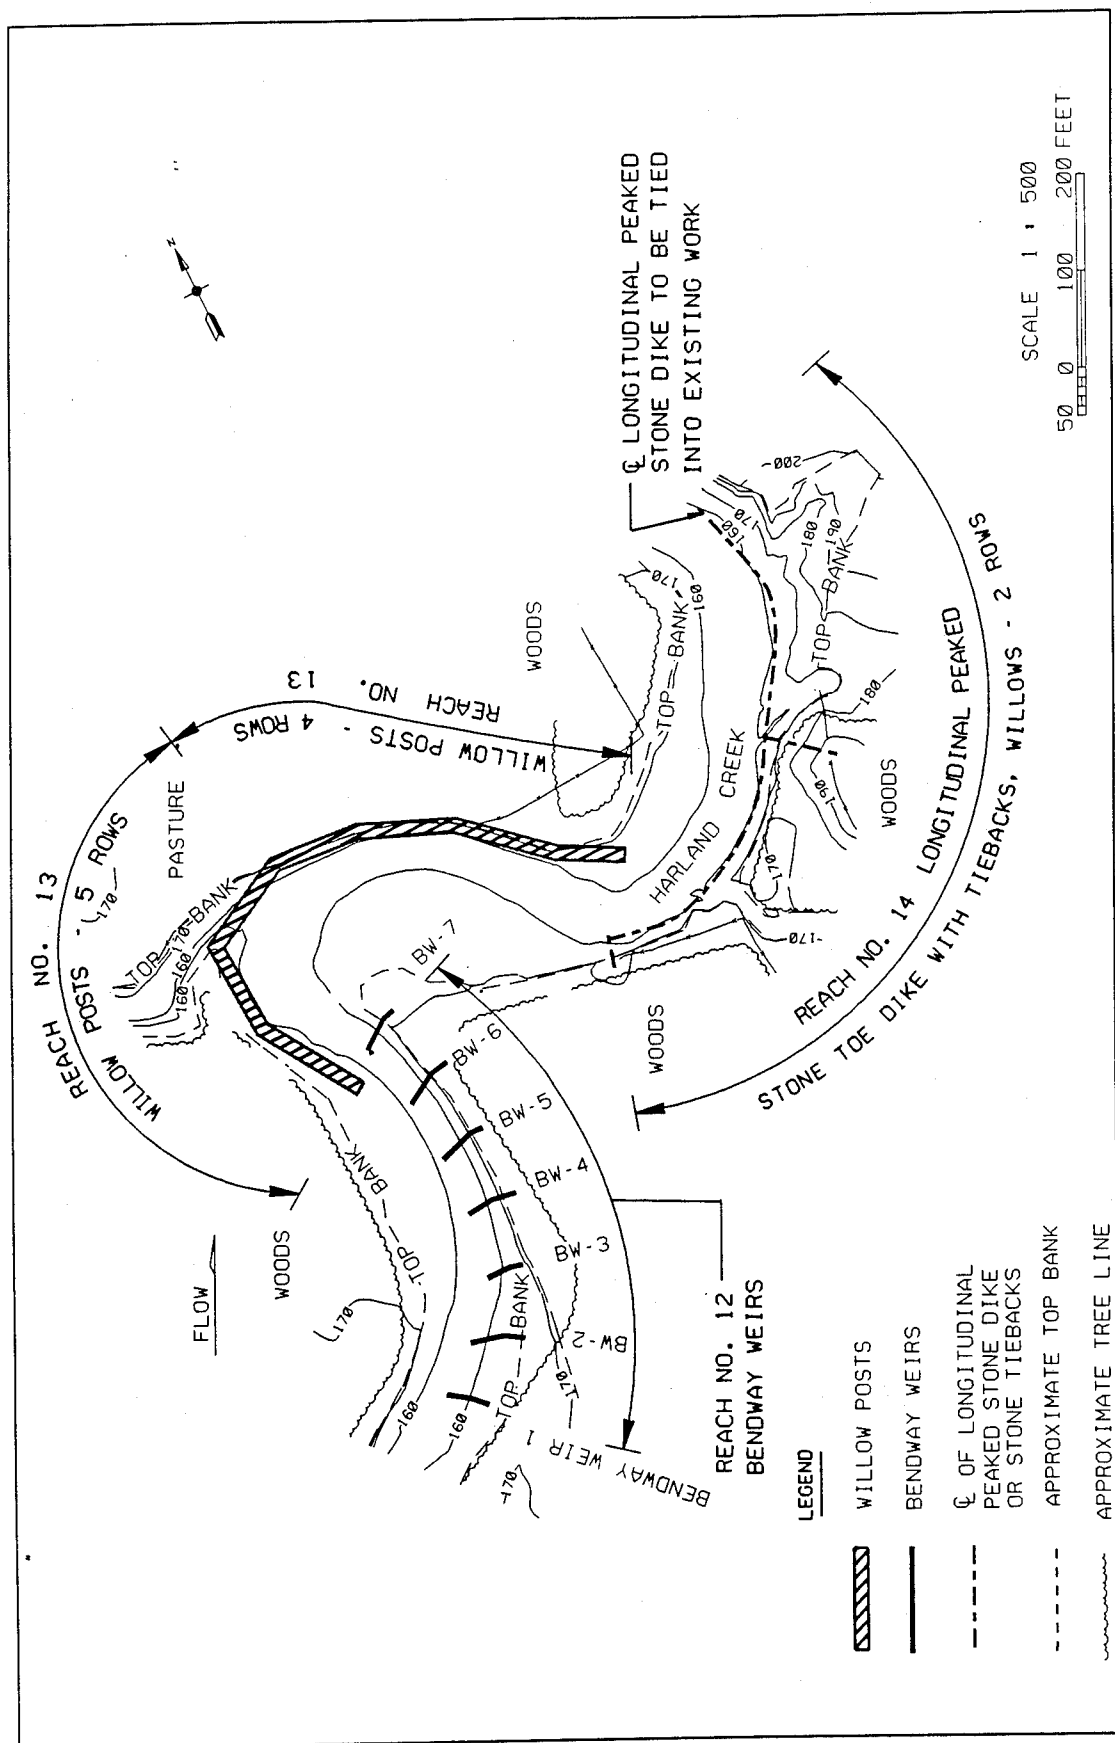
Figure 136. Harland Creek test site, reaches 12, 13, and 14

Reach geometry (curved) (Figure 136): 350-ft radius, 90 deg, top bank length 550 ft. Seven bendway weirs, all angled 20 deg upstream (except for weirs 1 and 7, which are both angled 10 deg upstream), all weirs spaced evenly at intervals of 75 ft and built to lengths of 30 ft. All weir heights were

set at el 162 ft NGVD for the stream end and el 164 ft NGVD for the bank end.

Reach geometry (multi-radius bend, then straight) (Figure 136): Section 1, curved, 185-ft radius, 72 deg, top bank length 230 ft; Section 2, curved, 375-ft radius, 62 deg, top bank length 405 ft; Section 3, straight for 55 ft; total top bank length of reach 690 ft. Bank protection will consist solely of willow posts. The upstream 230 ft of the bend will have five rows of willows, first row starting 5 ft from the water's edge, spaced 3 ft on center. The remaining 460 linear feet of bank will consist of four rows of willows, 3 ft between rows, willows on 3-ft centers, first row positioned at water's edge. Approximately 1,005 willows will be used in this reach. Section 1 of this bend has a very flat bank. The stream is on a 15- to 20-ft bluff for the remainder of the reach. Bendway weirs were not used in this reach since there is no bank to key into in Section 1 and with the sharp transition angle between Sections 1 and 2 it would be difficult to correctly angle the bendway weirs in this area.

Reach geometry (curved) (Figure 136): 295-ft radius, 133 deg, top bank length 685 ft. Bank protection consists of a Vicksburg District designed traditional 1-ton/linear-foot longitudinal peaked stone toe dike (with two tiebacks) and willow posts. The peaked stone dike follows the toe of the outer bank for most of the length of the reach and then ties into some existing bank paving near the lower end of the bend. The dike and tiebacks were constructed of R-200 stone (200-lb maximum weight stone). The first row of willows will be planted at the bank-side toe of the peaked stone dike and the second row 3 ft bankward. In each row willow posts will be spaced 3 ft apart. Approximately 469 willows will be planted in reach 14.
